Strategies for integral rehabilitation and improvement of the energy efficiency of Lagos Park building in Madrid

María Eugenia Maciá-Torregrosa, Javier Camacho-Diez and Roberto Alonso González-Lezcano*

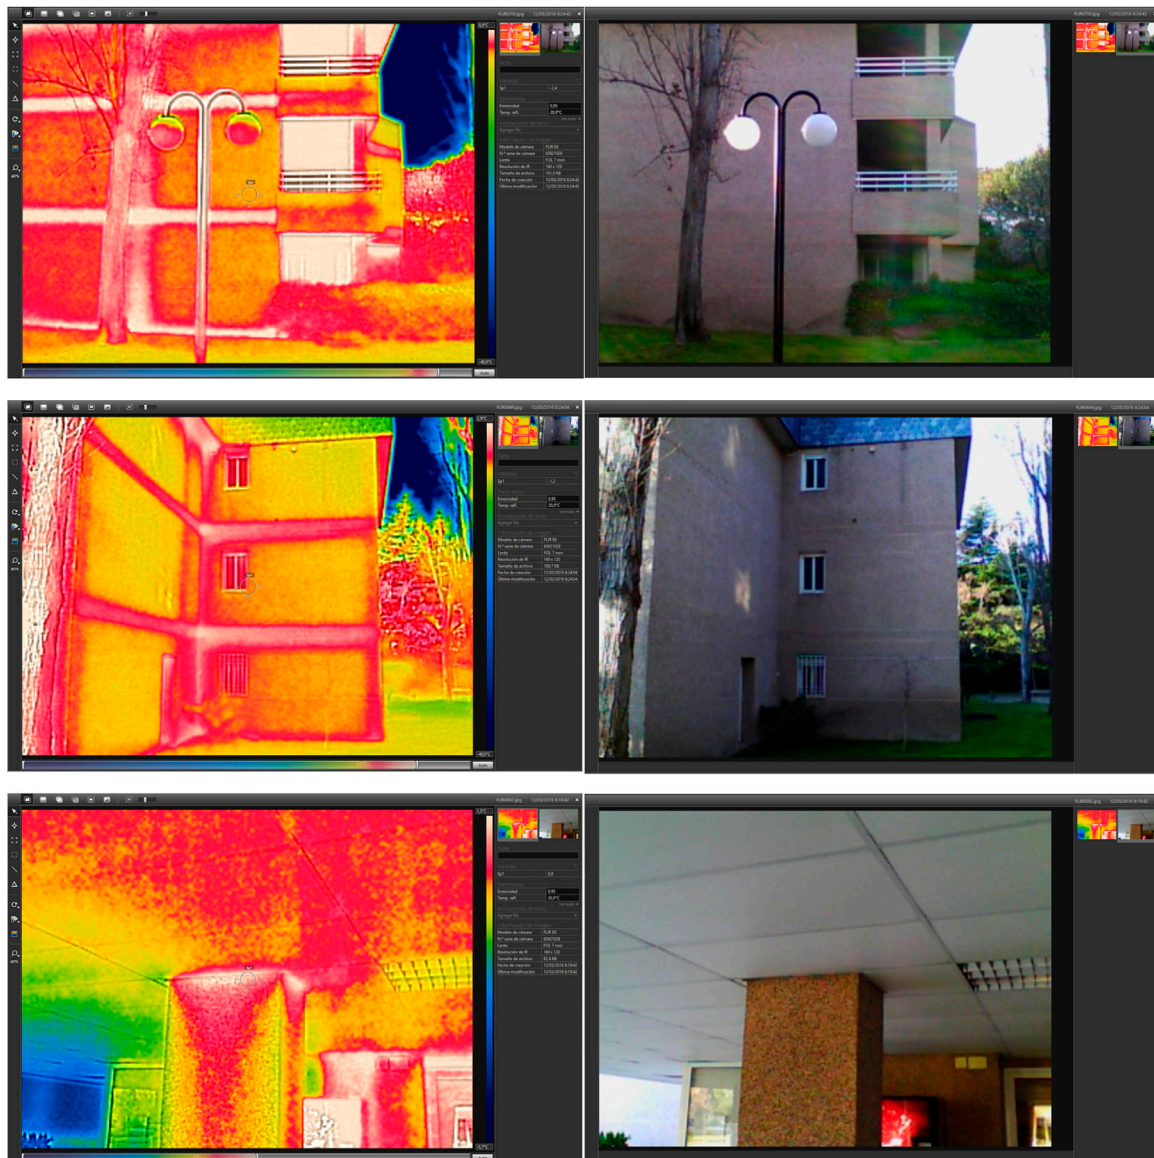
FIGURE 4 Thermographic images of different areas of the existing building.

The main challenge was the energy rehabilitation of the existing building complex. For this purpose, an extensive thermographic study was carried out in order to detect all pre-existing pathologies. Thermographic diagnosis is a widely used technique to reveal various types of building pathologies and also to determine an energy diagnosis. The problems detected in the thermographic camera study (Figure 4) are thermal bridges in slab edges and pillars, loss of airtightness and thermal insulation in the building envelope, water seepage in roof areas and air infiltration in many areas of the building.

From the analysis of the existing deficiencies and pathologies in the building and thanks to the thermographic images of the building, the lack of thermal insulation at the junction of the vertical structure (supports) and the enclosures, at the junction of the horizontal structure (slab edge) and the enclosures, at the junction of the lower floors (landscaped first floor) and the enclosures, under the living spaces over open porches, under the living spaces over the parking basement and in the walkable terraces over the living spaces is detected. In addition, thermal bridges are noted in jambs and lintels of exterior openings.
