Abanico Agroforestal. January-December 2021; 3:1-13. <http://dx.doi.org/10.37114/abaagrof/2021.2>
Original Article. Received: 18/12/2020. Accepted: 20/02/2021. Published: 19/03/2021. Code: e2020-16.

Analysis of the structure of the fighting bull's horn through image analysis. Horn sheath effect

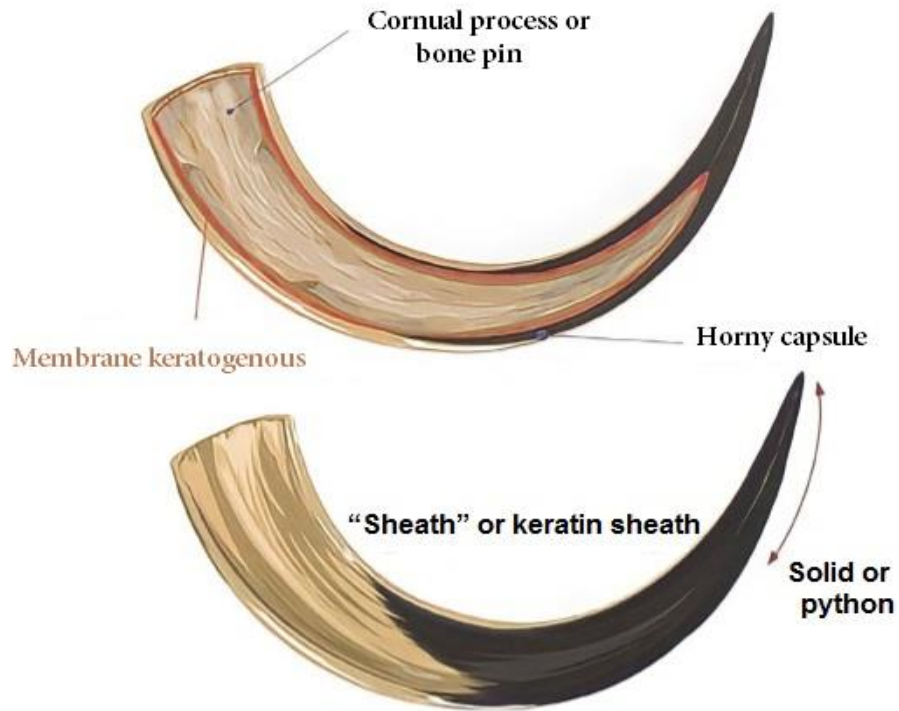
Figure 1. Anatomy of the bull horn (Calvo, 2005)

The horn is an epidermal production located on both sides of the forehead, supported by the bony projection of the frontal bone, adopting a conical and elongated shape; it is divided into 3 parts (Figure 1): proximal part or "stock" (also called cob), middle part or "shovel" and distal part or "piton" (Fernandez, 2009). As a bone product, its composition includes minerals such as calcium, iron, magnesium, sodium, potassium and phosphorus; depending on its hardness to a great extent (Cabanas *et al.*, 1994).

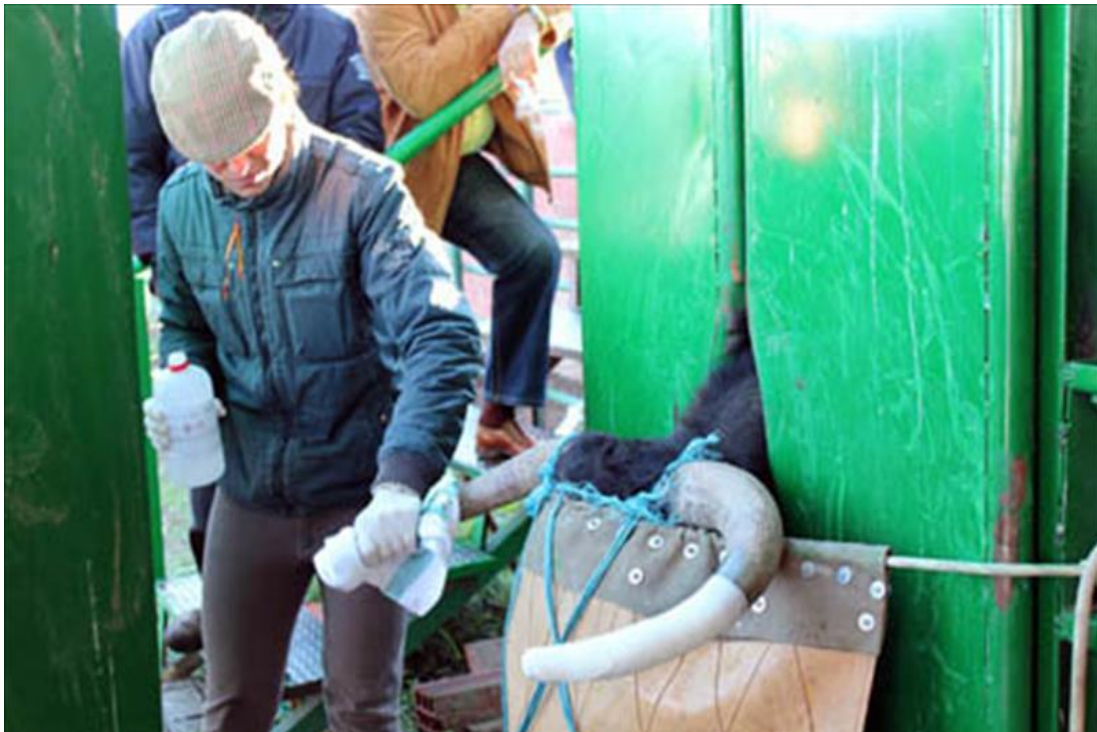
Figure 2. Sheathing management (Photo: Julio Cesar Sanchez, 2018)

Horns of bulls suffer a risk of deterioration, mainly in the last year of life, as a result of potential fights, rubbing, contact or blows with the ground, trees, and fences, feeding troughs or the walls of the chutes or handling pens (Aparicio *et al.*, 2000). For this reason, in recent years the use of a fiberglass bandage has become popular to cover the horns so that they are protected until they are fought in the arena (Lomillos *et al.* 2013). It is an easy to handle, porous material that hardens quickly by polymerization with water, providing good consistency (Figure 2). The technique consists of immobilizing the animal in the muzzle and wrapping the horn with this bandage to protect it from any aggression or rubbing. The distal part of the horn, i.e. the tip, is reinforced in many cases with a harder material, metal tubes or similar, in order to reduce wear in the apical area (Pizarro *et al.*, 2008a and b).

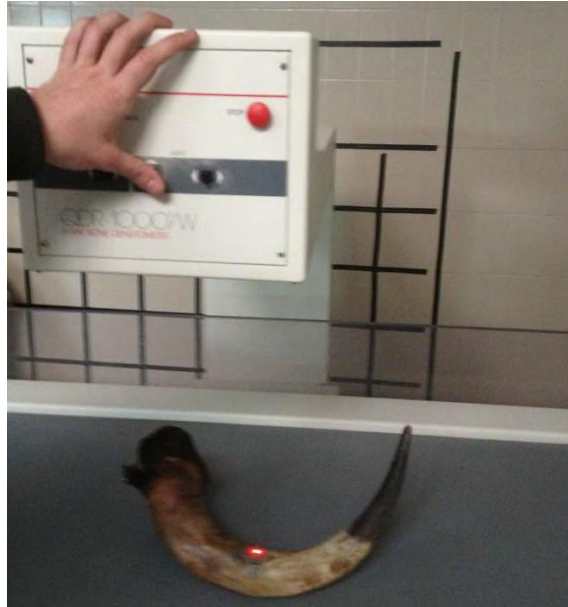
Figure 3. Laser localization of the midpoint of the horn

Since one of the determining aspects of the mechanical resistance of the horn is the degree of calcification of the bony structures that support it, it is considered necessary to evaluate the bone density of the cornual processes of the frontal bone, in order to verify the existence or not of influence of the sheathing at this level. A Hologic QDR-1000/W densitometry equipment was used; measurements were taken of both the proximal half of the horn (base) and the distal half (tip). To determine the two study regions, the midpoint of the horn located by laser was used as a reference (Figure 3).

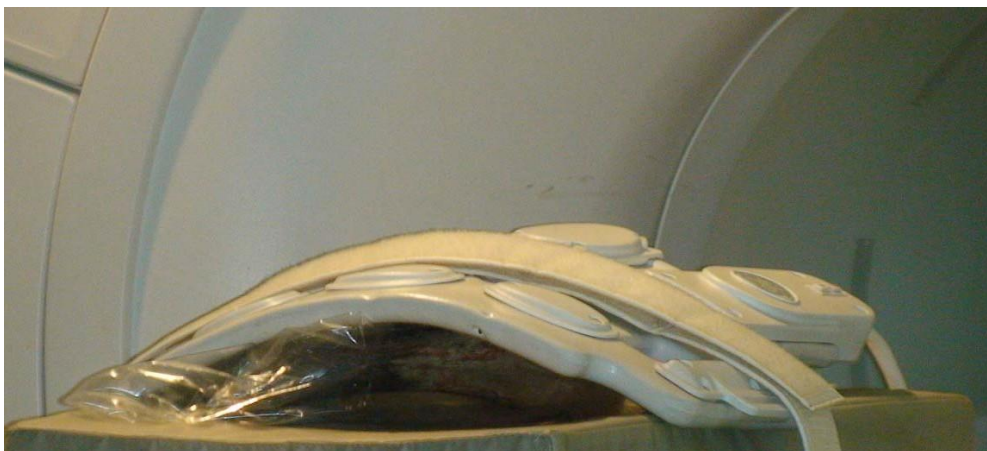
Figure 4. Covered horn with Cardio-array antenna

For this study a 3 Tesla closed magnetic resonance equipment was used, with superconductive magnet, General Electric Medical System brand; after two preliminary tests with a wrist antenna and a head antenna, it was decided to carry out the studies with a Cardio-array antenna (Figure 4), of the same brand. The images were processed using the OsiriX program, which allows precise measurements to be made on the images.

The horns were placed on two pads to center them in the magnet, in a position that would correspond to the supine decubitus position of the animal; but slightly more rotated to take advantage of the area of greater magnetic intensity.

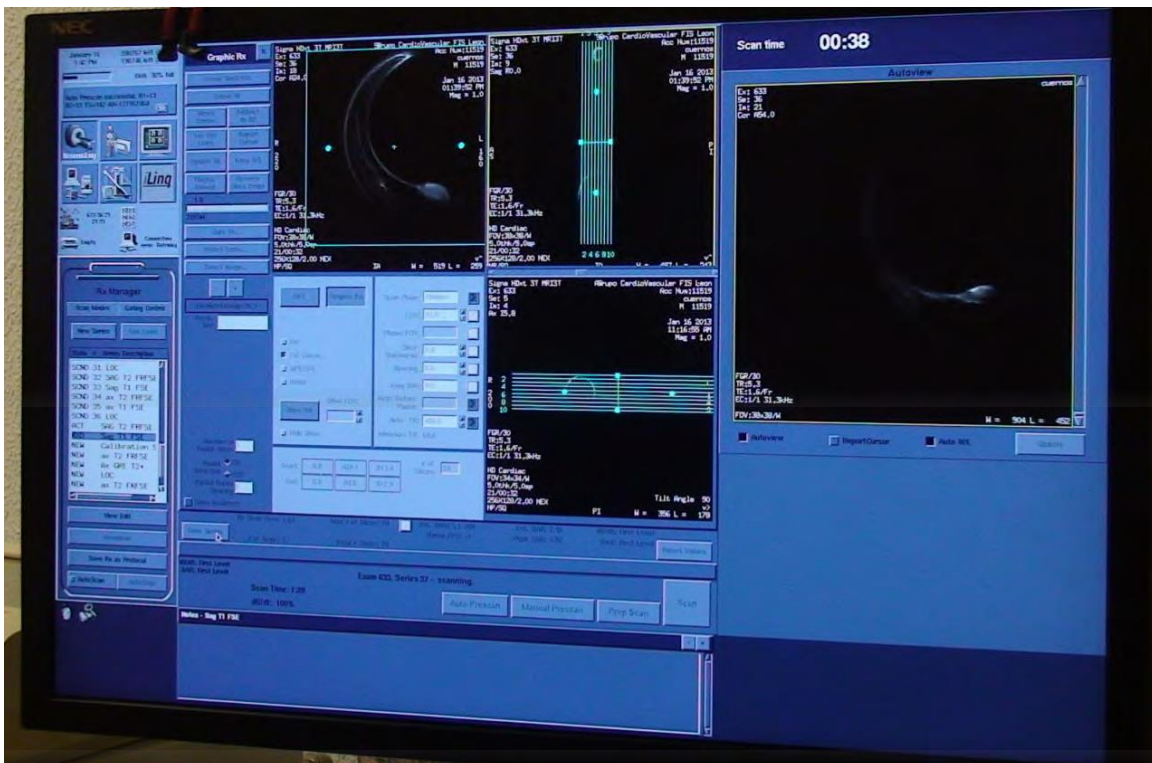
Figure 5. Image of 5 mm thick oblique coronal slices

The study technique consisted of a locator in 3 planes, with a second locator also in three complementary planes; oblique coronal slices were made on these, looking for the plane that covered the greatest length of the horn and covering the rest of the anatomy with the rest of the slices (Figure 5). These slices were 5 mm thick and 0.5 mm apart, which translates into a distance of 5.5 mm between slices. These images were acquired in T2 FRFSE and in T1SE.

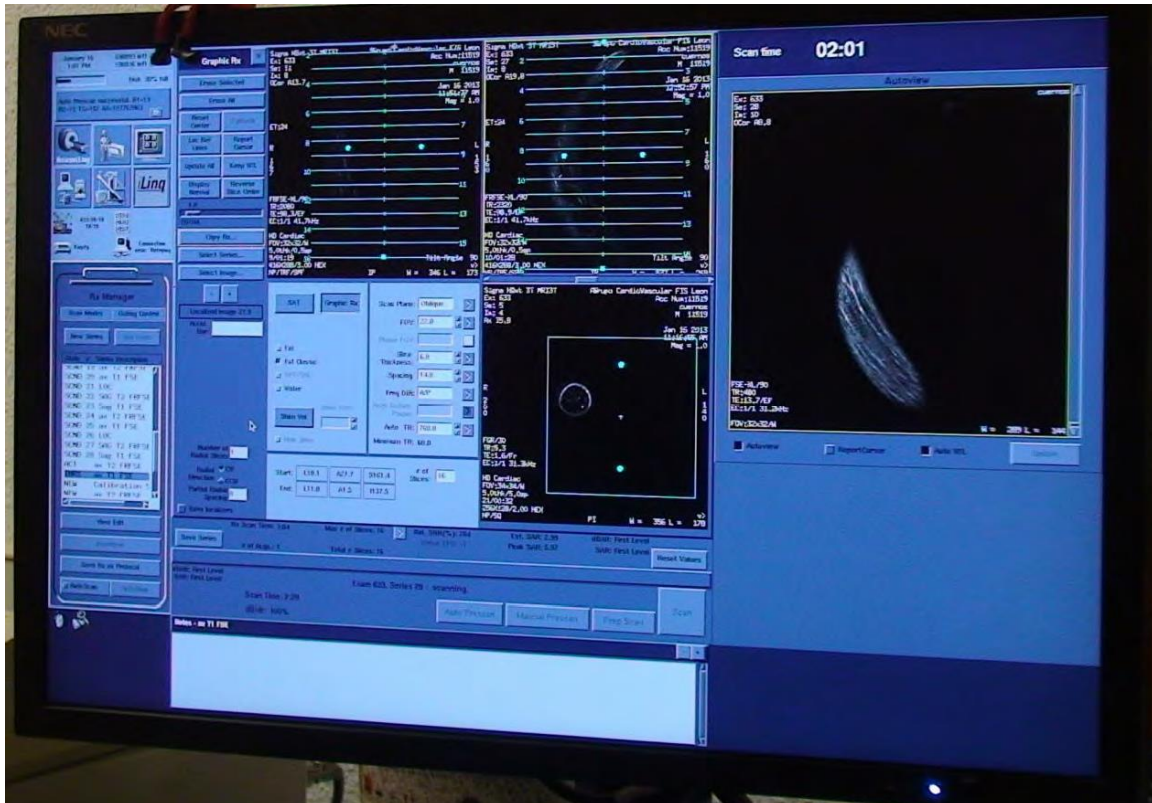
Figure 6. Image of the axial slices perpendicular to the coronal slices of 6 mm thickness

Axial slices were programmed on the previous images, perpendicular to the previous ones with 6 mm of thickness and 14 mm between slices (Figure 6); which gives us a distance between slices of 20 mm, which will facilitate the comparison of results with the rest of the techniques. These images were also obtained in T2FRFSE and T1SE.

The orientation of these axial series means that, as the slices are parallel to each other, the first two and the last two are very oblique, giving us an elliptical image of the bone section, the rest of the slices being reasonably perpendicular to the horn axis. All the data were processed using the SPSS program, performing a one-way analysis of variance (ANOVA), considering group 0 as the unsheathed animals and group 1 as the sheathed ones.

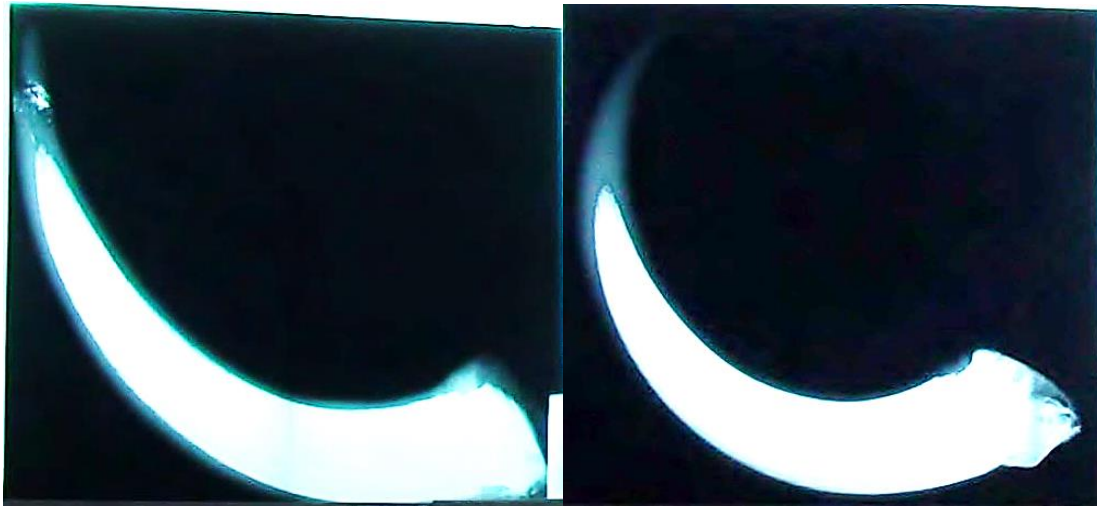
Figure 7. Radiographic images of a fractured horn and a healthy one

By means of radiography it is possible to distinguish perfectly different parts of the horn and therefore its internal structure. No serious alterations of the internal structure of the horns were found, nor were they compatible with chronic pathological processes in the bony area of any of the horns studied. However, some alterations were observed in the area of the horn massif, such as breaks or splinters, as can be seen in the upper left part of Figure 7, but in both animals of the sheathed and un-sheathed group.

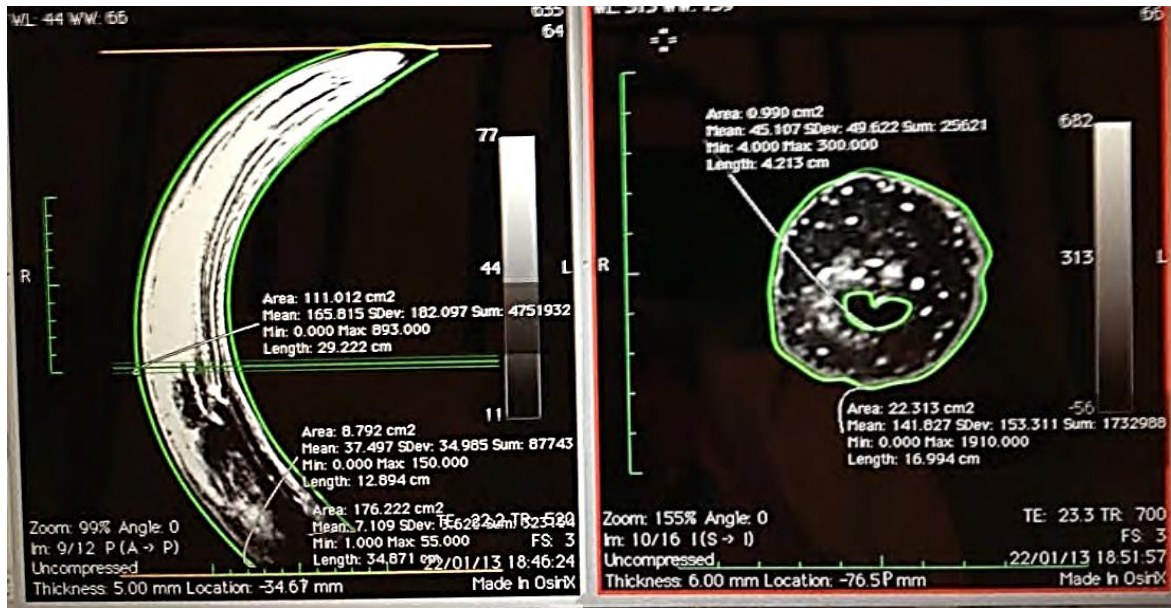
Figure 9. Magnetic resonance imaging of horn; coronal and axial section with a trabecular zone of 12.9 cm in external length

Finally, through magnetic resonance imaging we have clearly observed the patterns of the vascular channels and the dermis that appear as radiolucent areas; as well as the extension of the different cavities and trabecular area of the horn (Figure 9).

In the magnetic resonance images we have found very evident differences in structure between individuals, both in the extension of the cavity or trabecular zone, as well as in the patterns of the channels; but no evidence of pathological alterations has been discovered.
